**DECEMBER 2003 STATUS REPORT – EARTHQUAKE RECOVERY PROJECTS**

## **Earthquake Recovery Projects**

**All Supervisorial Districts**

December 31, 2003

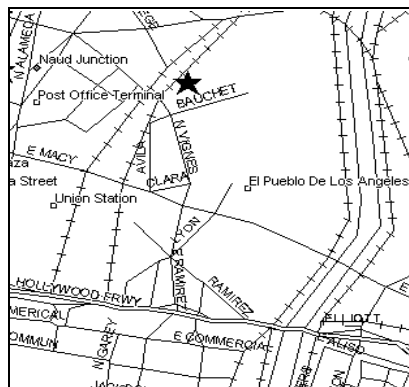
Spec #: 5690

The scope of work includes repair via epoxy injection of cracks in the concrete deck of the parking structure and repair of cracked/spalled concrete members which support the concrete deck.

Of an estimated 23,220 linear feet of concrete cracks, a total of 19,931 linear feet had been repaired in June 2003. All repairs of concrete cracks and spalled concrete were completed in July, and substantial completion was declared on 7/30/03, five weeks ahead of schedule and within budget. The contract acceptance memo was issued on 10/28/03. The project is complete.

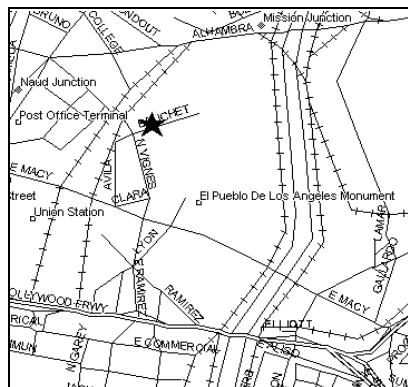
Spec #: 5521

Damage includes cracks in shear walls and columns throughout the facility and a broken concrete block wall at the exercise yard. The repair scope of work includes the epoxy injection of concrete cracks in structural members. Hazard mitigation funds were authorized by FEMA for the strengthening of concrete shear walls and the construction of new concrete shear walls. The latter requires the reconfiguration of jail cells in the Infirmary building. Non-structural work includes repair of building finishes and Title 24/ADA - Accessibility code compliance.
